## Carpet Manufacturer Cuts 95% of Scrap Losses with Simplicity Selflubricating Bearing Solution

Rockford, IL - March 8, 2010

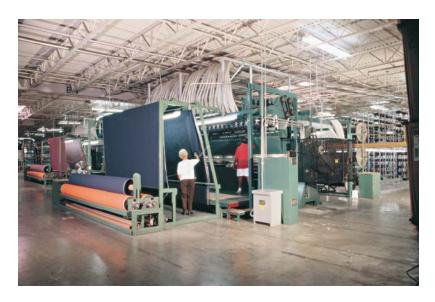
Carpet tufting system.

Each carpet tufting machine uses 36 ball bushing bearings and steel shafting assembled into a pushdown foot system (4 bearings and 2 rods of steel shafting per pushdown foot, an average of 9 pushdown feet per machine). This system is utilized within the application to operate the needle bar in quick, reciprocating up to 1600
